**HARLOW BROOK NO. 1 DAM
MA 00032**

**PHASE I INSPECTION REPORT
NATIONAL DAM INSPECTION PROGRAM**

APRIL 1979

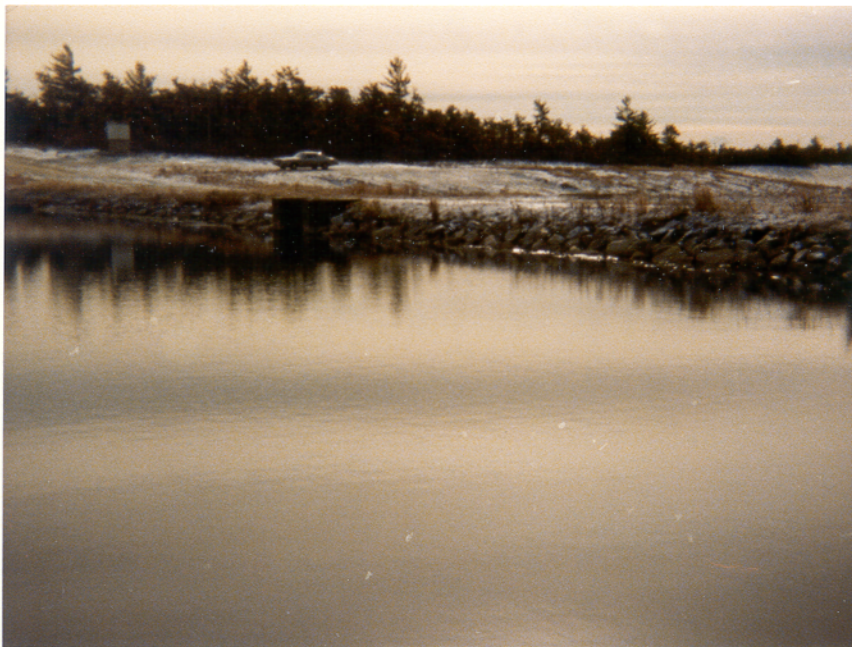
The upstream slope is covered with riprap. The stones range in size from 6 to 18 inches. The slope and riprap are both in good condition. A stone wall protects the bottom third of the downstream slope from the discharge water which is immediately ponded by Harlow Brook Dam No. 2. The wall consists of stones 6 to 30 inches in size. Stones are missing in the vicinity of the discharge conduit. The upper two-thirds of this slope is protected by vegetation. This vegetation is growing close together and bare soil is exposed. Surface runoff has cut gullies 2 to 4 inches deep in the slope. This slope is in fair condition. Vehicular traffic

NO. 1 UPSTREAM SLOPE OF DAM

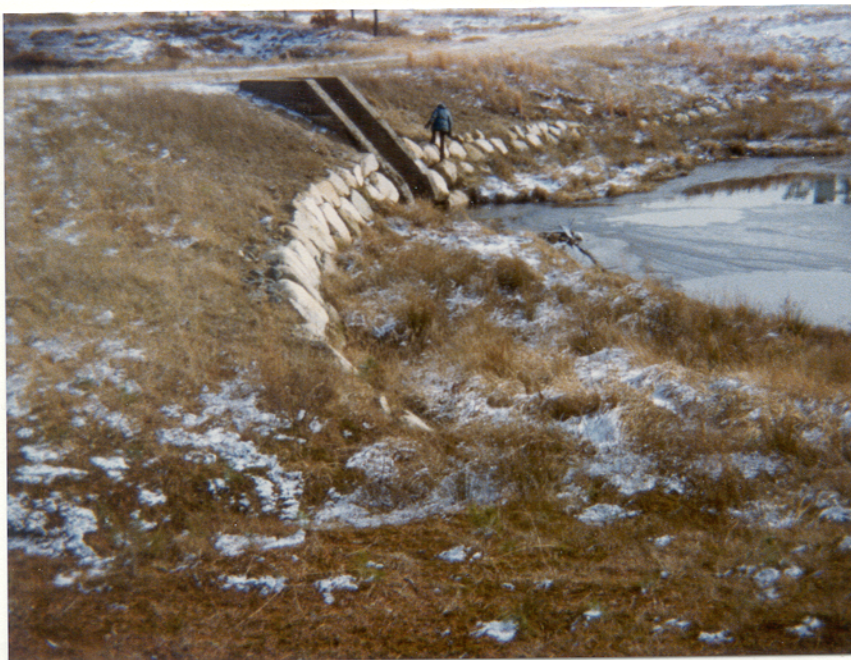
- b. Dam. Harlow Brook Dam No. 1 is an earthfill dam with an outlet structure through the center of the embankment. Seepage through and under the dam has formed a small pool at the toe about 30 feet west of the discharge channel. The water in this pool is colored orange. A hole was observed at the toe of the dam about 45 feet east of the discharge channel. This area was wet. The hole was circular but could only be probed to a depth of 1 foot. The hole was possibly caused by seepage under the dam or is an abandoned outlet pipe. Seepage from this hole has eroded a small gully 3 to 6 inches deep.

NO. 2 DOWNSTREAM SLOPE AND OUTLET STRUCTURE

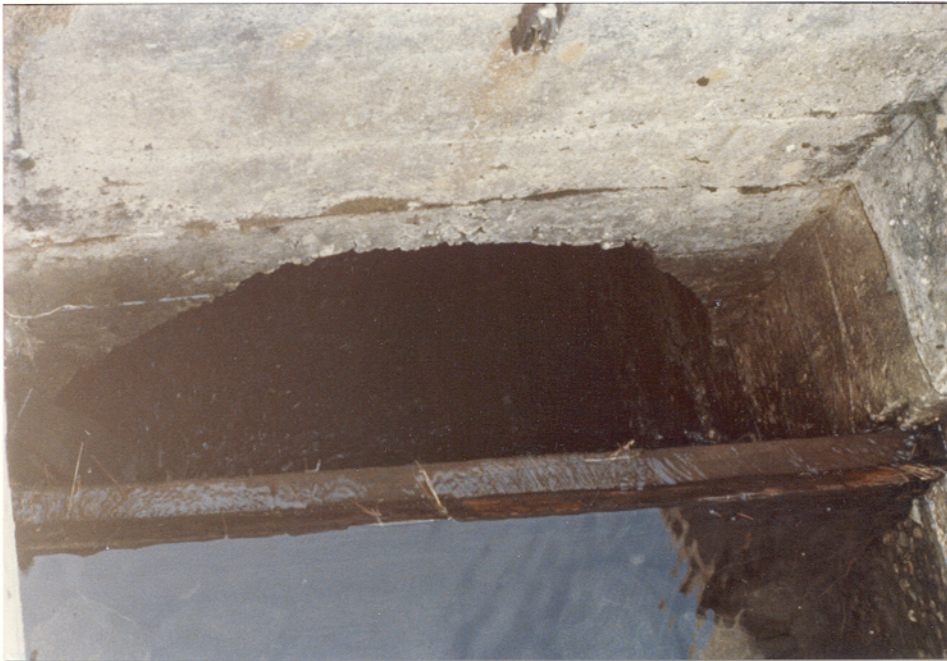
- c. Appurtenant Structures. The outlet structure is a 41-foot long arched concrete conduit that is located 30 feet west of the center of the dam. The conduit is in poor condition. The approach channel to this structure has concrete side walls extending to the bottom of the slope and a bottom lined with rock. Wooden stoplogs extend from El 45.9 down to El 36.0. There is leakage between the stoplogs. This section of the outlet structure is in good condition.

NO. 3 STOPLOGS AT INLET STRUCTURE

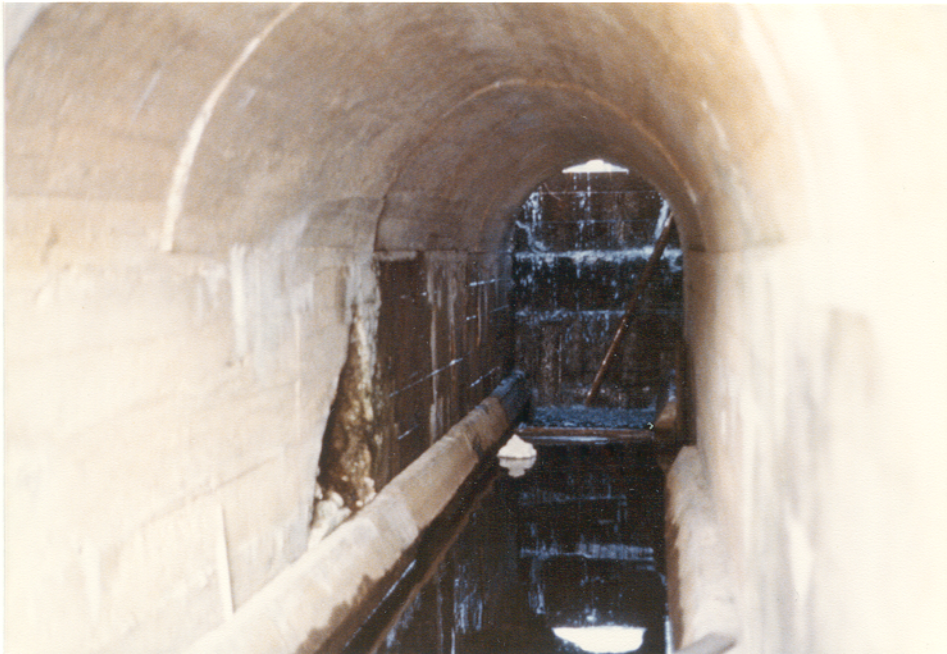
The conduit has severe spalling on the west wall (see Photograph No. 4). The reinforcing steel within the wall is exposed and corroding. The spalled area is triangular in shape and covers 8.5 square feet. This area was wet and dripping at the time of the inspection. The water is apparently coming through the concrete wall. An 8-inch wide curb runs along both sides of the conduit at the base of the walls. The bottom of the conduit is concrete. The curb is undermined about 1 foot in the vicinity of the spalled area. A 10-foot section of the curb is missing on the east side of the conduit.

NO. 4 DISCHARGE CONDUIT

- (1) repair the concrete wall in the conduit
- (2) repair spalled section of wall and fill in undermined areas in the conduit and discharge structure
- (3) backfill and protect the eroded areas on the slopes of the dam
- (4) replace missing riprap on the downstream face of the dam
- (5) replace dislodged and missing stones in the discharge channel and remove debris
- (6) implement a systematic program of maintenance inspections. As a minimum, the inspection program should consist of an annual periodic technical inspection of the dam and appurtenances, supplemented by additional inspections during and after severe storms. All repairs and maintenance should be undertaken in accordance with all applicable State regulations.

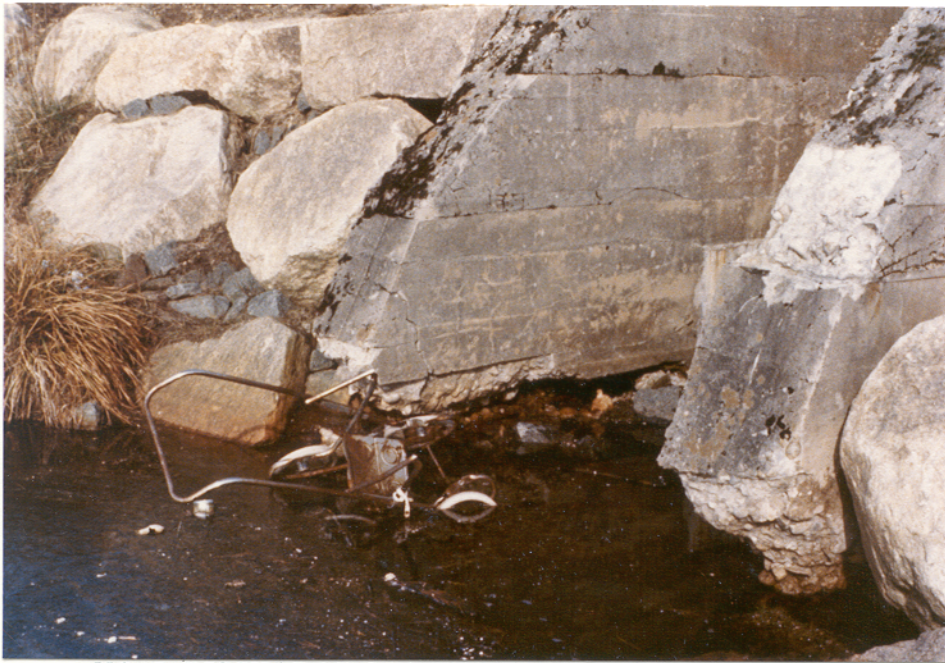
Side walls of the discharge channel show staining and spalling. The walls are undermined at the toe of the slope. The bottom of the channel is constructed of placed stone and is cluttered with debris. Some of the stone has been dislocated and is missing. The discharge channel is in fair to poor condition.

NO. 5 DISCHARGE CHANNEL AT OUTLET STRUCTURE

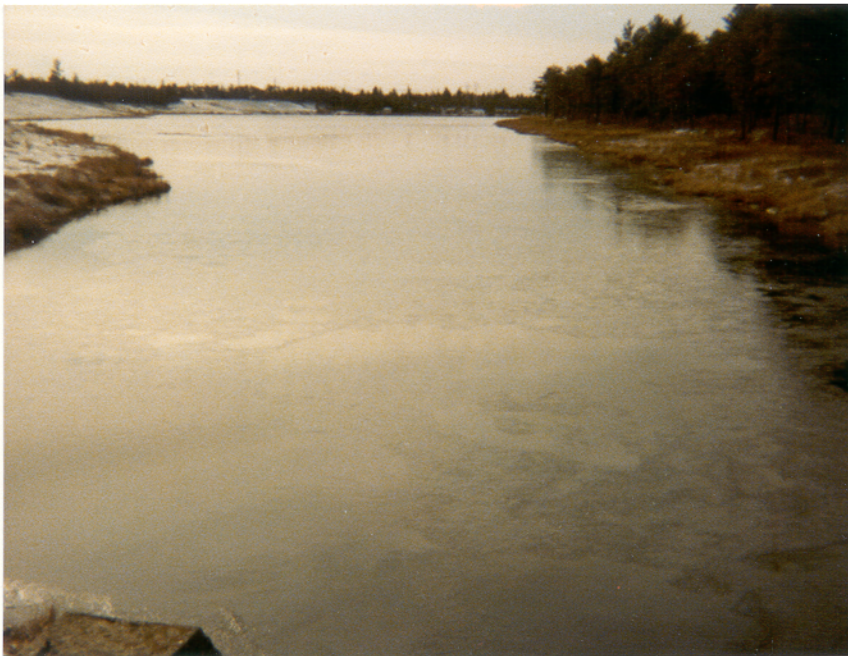
Dam No. 2. Below Dam No. 2 are cranberry bogs. These bogs extend from the toe of the dam to Route 25, a distance of 6,500 feet. Route 25 in this area is a high embankment highway. In the event of complete failure of the dam, it is unlikely that extensive property damage would occur or that any lives would be lost. Accordingly, the dam is placed in the "low" hazard category.

NO. 6 VIEW DOWNSTREAM FROM DAM
